TELEVISION INSPECTION REPORT

DEMO ONLY — synthetic inspection site

REFERENCE  
DEMO-EN-TRAJECTORY-40M

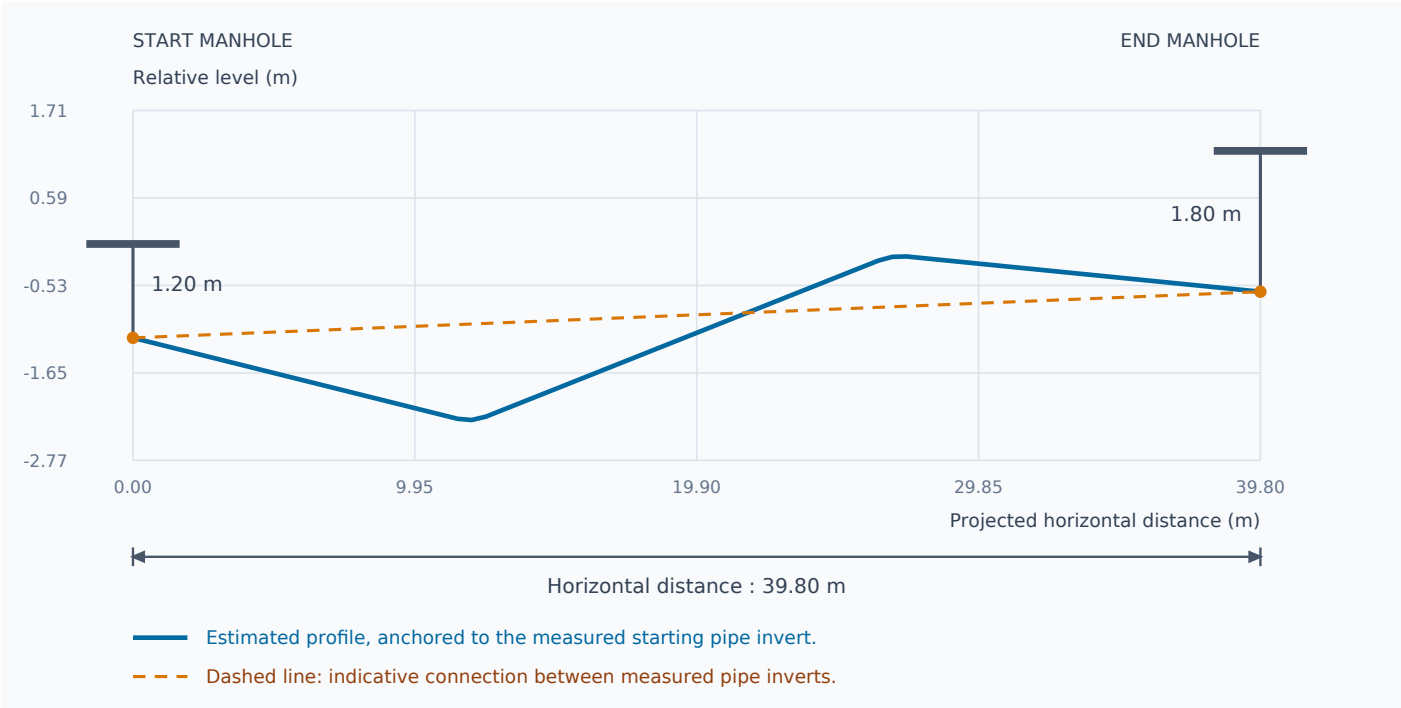
End manhole top level – start top level : **1.19 m**.

Elevation difference between pipe inverts : **0.59 m** · Horizontal distance : 39.80 m · Estimated mean gradient : **1.48 %** (14.8 ‰).

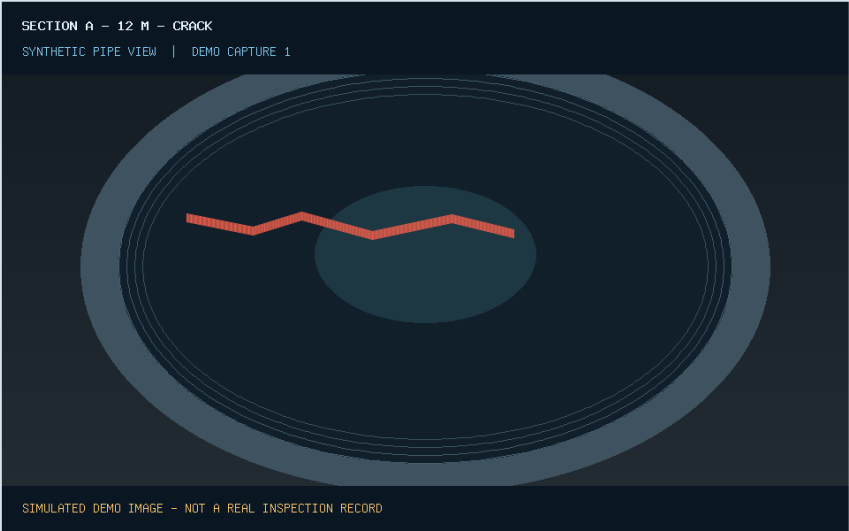
| Inspected Meter: 12 M BABAA Picture 1 |

| CRACK |
| MICRO-CRACK, PRESENT ON THE SURFACE |
| LONGITUDINAL |
| 2 mm |
| DEMO ONLY: simulated 2 mm crack. |

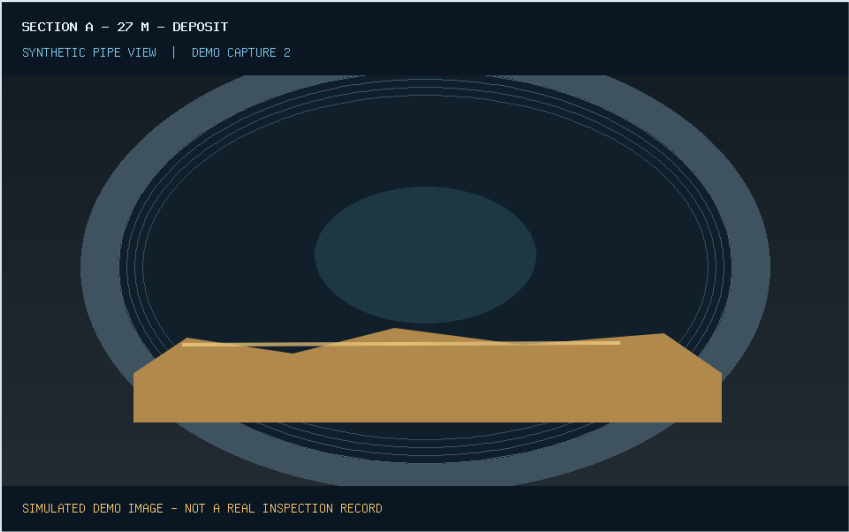
| Inspected Meter: 27 M BBBCA Picture 2 |

| DEPOSITS |
| FINE (SAND, MUD) |
| 18 |
| DEMO ONLY: simulated fine deposits. |

Hypothetical recommendations for the demo: clean deposits in Section A and review root removal and the repaired area in Section B. No physical work is requested.

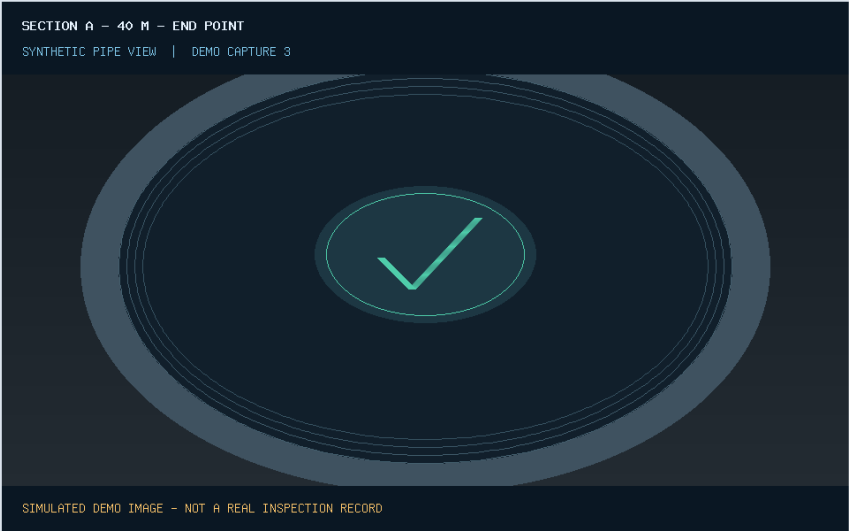
| Inspected Meter: 40 M BDA Picture 3 |

| GENERAL PHOTOGRAPHY |
| DEMO ONLY: end of simulated Section A. |

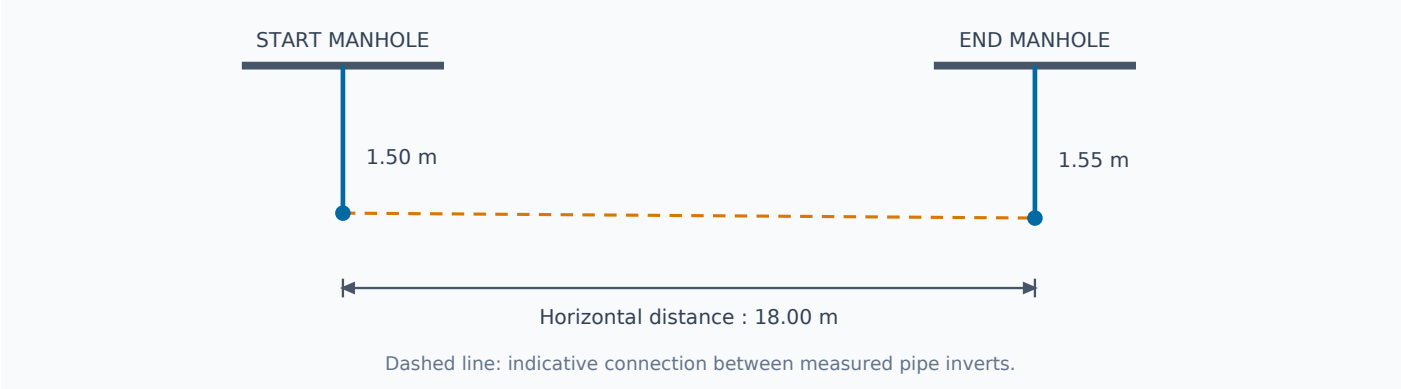
End manhole top level – start top level : **0.00 m**.  
Elevation difference between pipe inverts : **-0.05 m** · Horizontal distance : 18.00 m · Mean gradient : **-0.28 %** (-2.8 ‰).  
From start to end: + means uphill; – means downhill. The connection between manholes does not describe intermediate irregularities.

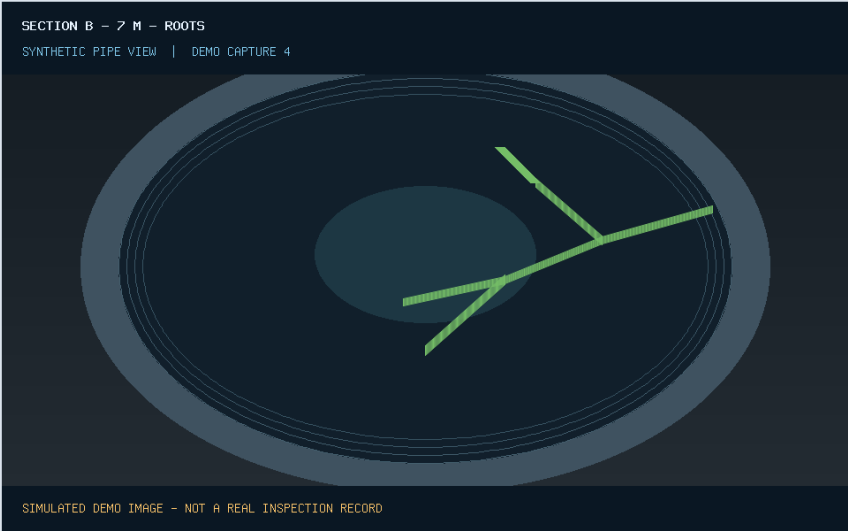
| Inspected Meter: 7 M BBAA Picture 4 |

| ROOTS |
| LARGE ROOT ISOLATED |
| 35 |
| DEMO ONLY: simulated root intrusion. |

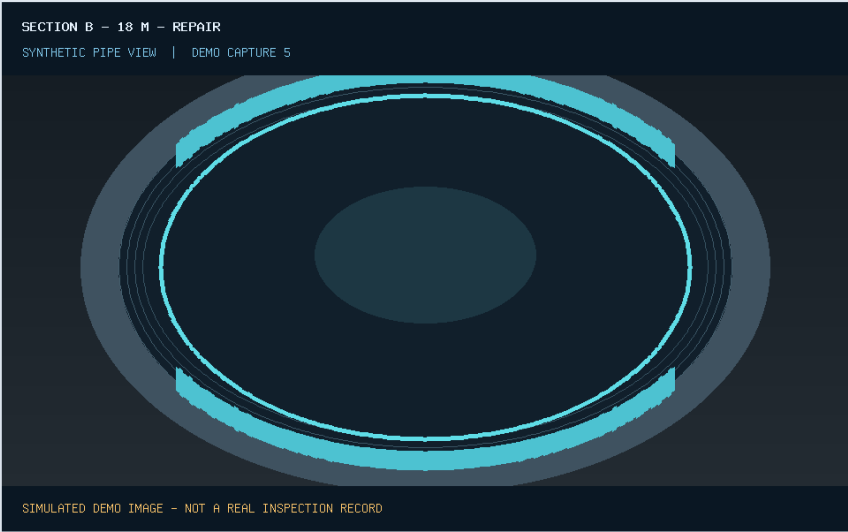
| Inspected Meter: 18 M BCBA Picture 5 |

| POINTUAL REPAIR |
| PIPE REPLACEMENT |
| DEMO ONLY: simulated pipe replacement. |
